Pentium® Pro Processor Specification Update

Release Date: October 1998

Order Number: 242689-032

The Pentium® Pro processor may contain design defects or errors known as errata which may cause the product to deviate from published specifications. Current characterized errata are documented in this Specification Update.

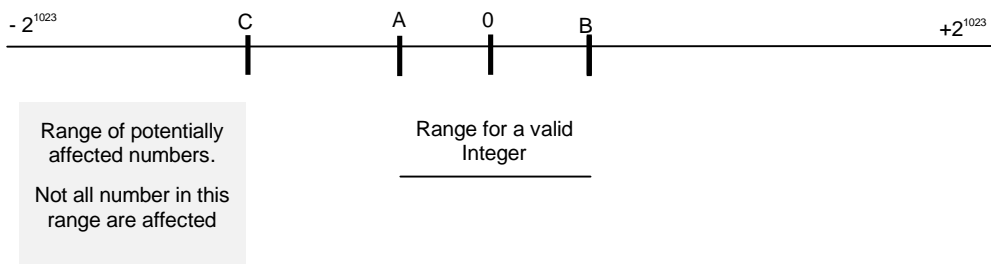
IMPLICATION: Erroneous operation results when the operand is so large that it will not fit into the target data size. The operands affected by this erratum are significantly outside (by a factor of 3X) the range that can be, correctly, converted to an integer value. The figure below and corresponding table identifies the normal range of integer numbers (between A and B) and the starting point of the operands affected by this erratum. Discrete failing operands will be present in the range between point C and the maximum negative number that can be represented by the processor (-2^{1023} in double precision format). Note 2 below gives a qualitative description of the nature of the discrete failing values. Software that does not rely on the Invalid Operation exception flag being set and signaled by either an exception OR by software polling is not impacted by this erratum.

16-bit Operation	A	B	C
	-32,768.0	+32,767.0	< -98304.0
32-bit Operation	A	B	C
	-2,147,483,648.0	+2,147,483,647.0	< -6,442,450,944.0

WORKAROUND: Any of two software workarounds will avoid occurrence of this erratum:
